Damage of SOx Scrubber Discharge Water Lines

Machinery Department, Plan Approval and Technical Solution Division, ClassNK

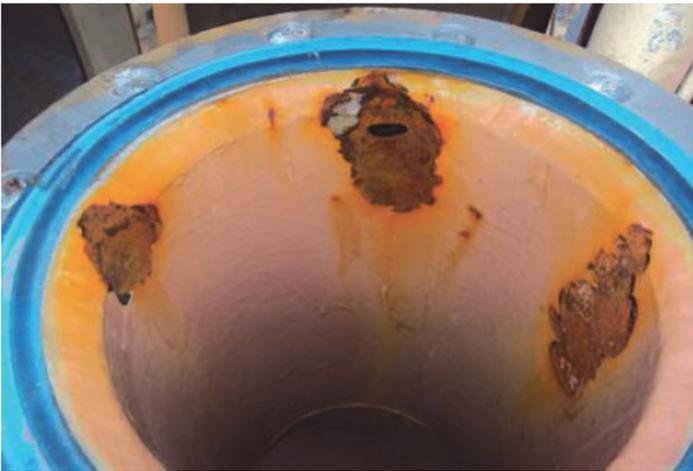
Fig. 2 Corrosion around welded parts between distance piece and flange

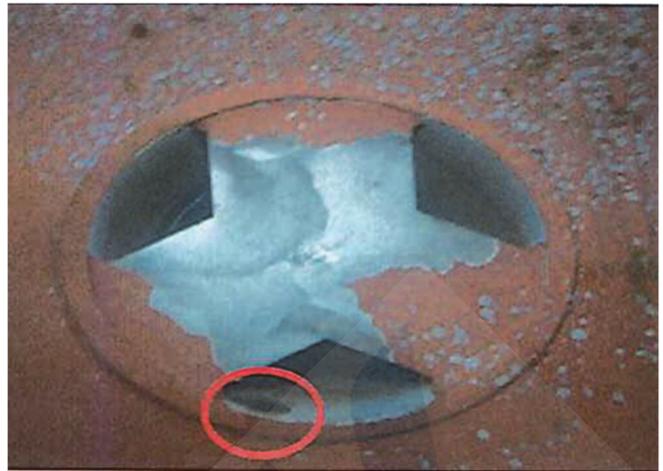
Fig. 3 Corrosion around welded parts between distance piece and bluff body

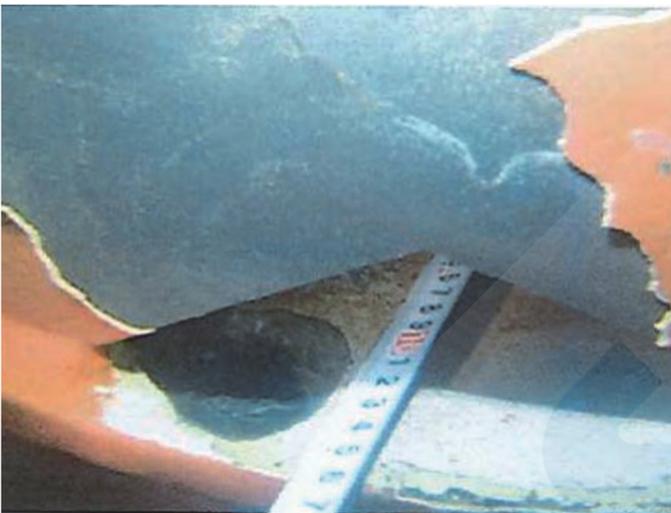
Fig. 4 Corrosion around welded parts between distance piece and bluff body

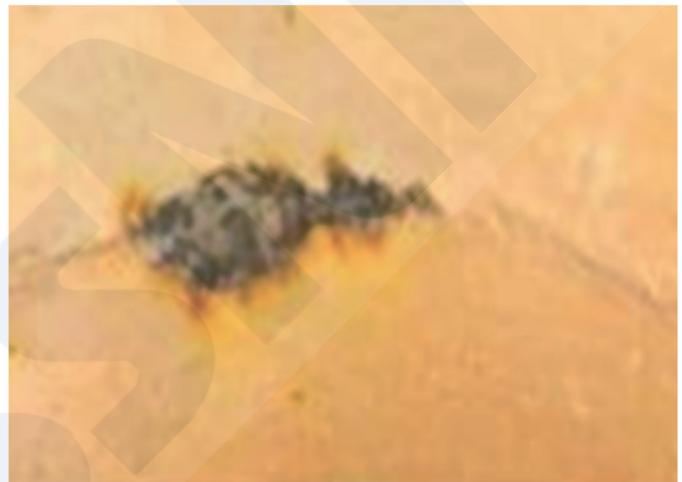
Fig. 5 Paint peeling at butt-welded parts of distance piece of discharge water system

If an appropriate corrosion-resistant paint is applied and the installation quality is adequate, painting is considered to be sufficiently effective as a corrosion countermeasure. In order to prevent corrosion due to inadequate painting quality, it is important to pay special attention to pre-painting procedures and paint application, and to ensure that the procedures specified or recommended by the paint manufacturer are followed.

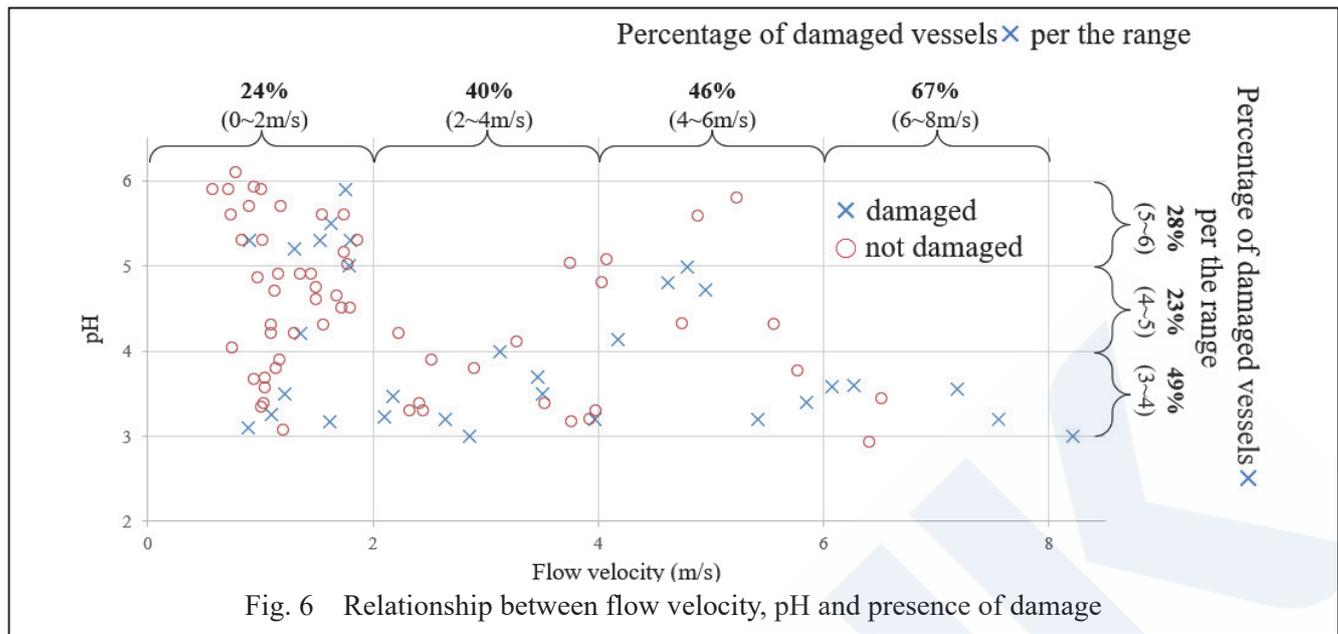
Fig. 6 shows the relationship between the data on the flow velocity and pH of discharge water and the presence of damage on vessels equipped with SOx scrubbers in ClassNK vessels. These data were extracted from a population of damage cases reported to the Society and cases in which no damage occurred, so there is no bias among SOx scrubber manufacturers. The data for the percentage of damaged vessels per flow velocity range show that the percentage of damaged vessels increases as the flow velocity increases (from 24 % to 67 %). However, there were cases where damage occurred even though the flow velocity was low, and conversely, cases where damage did not occur even though the flow velocity was high (the same was true for pH), suggesting that damage was not caused by one factor alone, but by a combination of several factors.
