Crack Damage on Cylinder Cover Cooling Jacket of Diesel Engine used as main propulsion

## ***Technical Information***

No. TEC-1158  
Date 20 July 2018

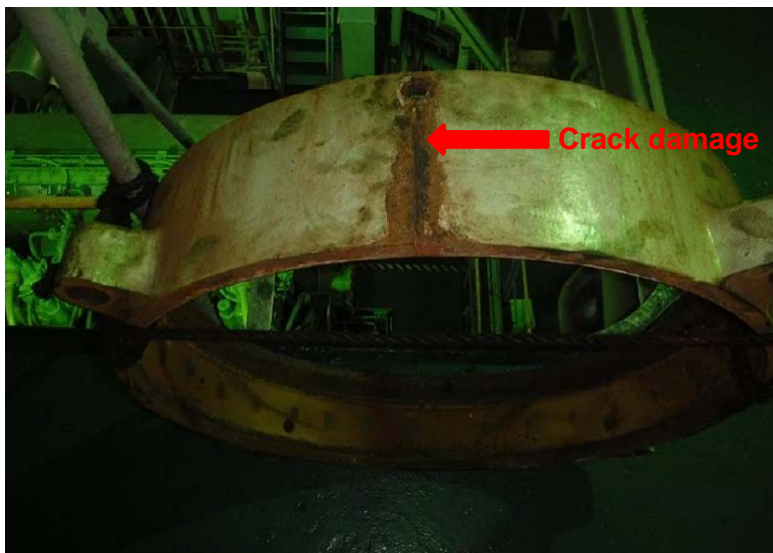
The cracks were initiated from bolt holes in many cases, resulting in a large amount of cooling water leakage (see Photograph 1).

Photo 1 Crack damage on cooling jacket, initiated from bolt hole in many cases.

Cooling water leakage due to such cracks will lead not only overheating of the engine but will also induce the auto-slow down and/or auto-stop of the engine. In the worst case, it might lead to a serious casualty such as grounding or collision due to loss of main propulsion.

The engine maker released a service letter in January 2014 concerning this damage, including how to maintain the relevant parts properly. For details, please refer to the following:

It is recommended to ship owners, management companies and operators managing ships on which the same types of diesel engines are installed onboard to refer these letters and to call necessary actions to the ships.
