Corrosion of distance piece on SOx scrubber discharge water line

Technical Information

No. TEC-1205
Date 9 April 2020

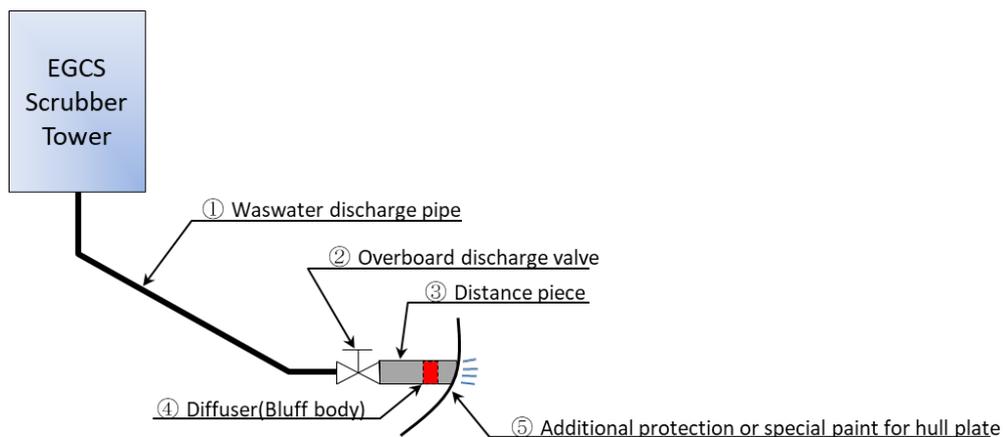
Figure 1 SOx scrubber discharge water line

Recently, ClassNK has received several reports for incidents that sea water leakage was detected from distance piece attached to hull on SOx scrubber discharge water line (See Figure 1).

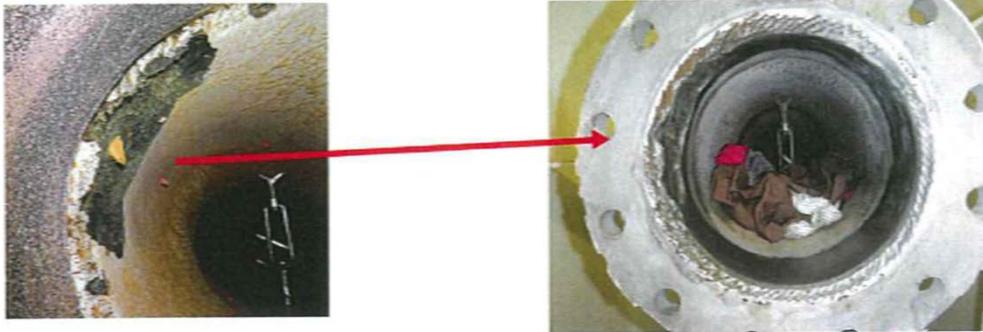
Leakages have been detected around welds between "distance piece" and "flange (See Picture 1) or bluff body (See Picture 2)".

Having inspected the distance pieces internally, the corrosion occurred/progressed around the welds and caused the leakages finally.

Picture 1 Corrosion around weld between distance piece and flange

- To inform the above incidents of the masters of your vessels on which SO_x scrubber is installed and instruct them to inspect the discharge water lines especially around the distance pieces externally from E/R with more attentions and frequencies.
- To inspect the distance pieces internally when there is an opportunity of arranging a diver for hull cleaning, etc.

If a leakage were detected, temporary countermeasure to stop it (e.g. covering the distance piece with cement box) should be taken immediately, and Occasional Survey by the surveyor should be arranged as soon as possible.

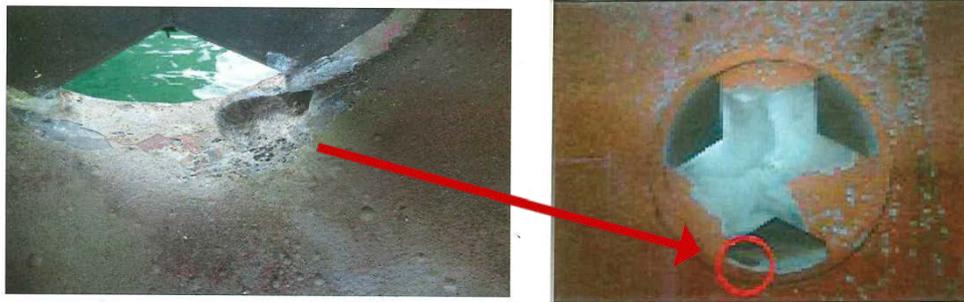
Picture 2 Corrosion around weld between distance piece and bluff body
