Corrosion of distance pieces associated with SOx scrubber discharge waterlines (Part 2)

ClassNK

Technical Information

No. TEC-1214
Date 4 November 2020

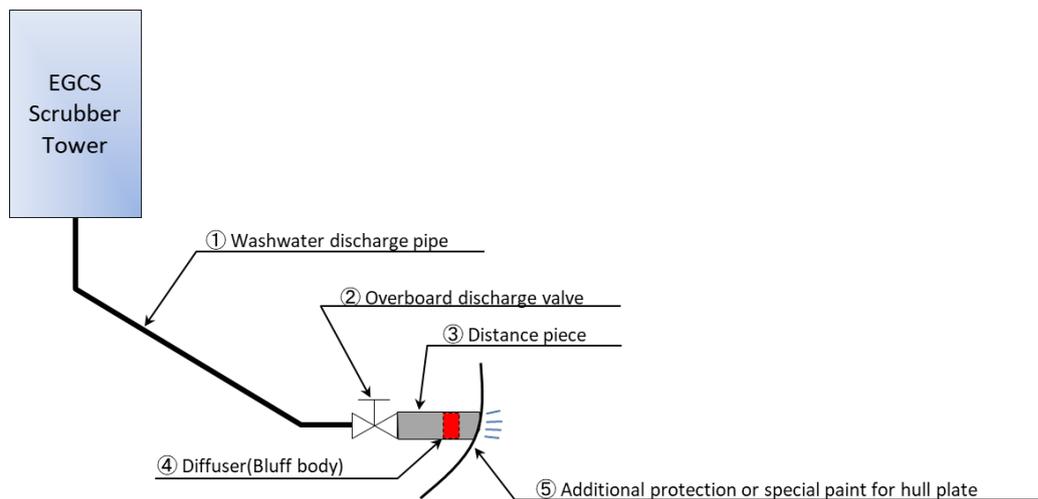
Figure 1 SOx scrubber discharge water line

As previously noted in ClassNK Technical Information (TEC-1205), ClassNK received several reports of cases of sea water leakage being detected in damaged distance pieces (due to corrosion) of SOx scrubber discharge waterlines fitted to hull structures (see 3 in Figure 1). Since similar incidents are still being reported, ClassNK has decided to publish this Technical Information not only to remind our clients that this remains an ongoing concern, but also to provide the following related information.

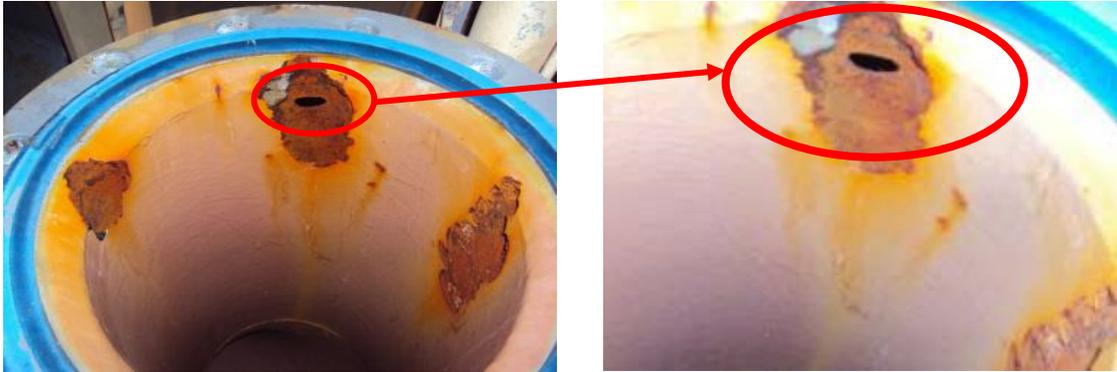
According to damage reports received to date, sea water leakage has been observed either on or adjacent to welded parts between distance pieces and their associated flanges (see Picture 1) as well as between distance pieces and bluff bodies (see Picture 2). The reports indicate that the corrosion apparently initiates at the welded parts and then continues to progress until it finally leads to sea water leakage into engine rooms. A peeling of the painted surfaces of the butt-welded parts of distance pieces (see Picture 3) has also been observed.

Picture 1 Damage on/around welded parts between distance pieces and flanges

Based on the circumstances of the situation, the damage is assumed to begin at locations on welded parts where the paint has been peeled off. The underlying surface is thus directly exposed to discharge water, and it causes corrosion that then spreads over the distance pieces over time.

ClassNK believes that one of the effective ways to prevent this type of incident is to apply pre-treatment prior to the painting of welded parts in order to ensure proper paint performance, and some specific pre-treatments are introduced below as examples. In addition, please be sure to comply with the pre-treatment procedures specified by paint manufacturers, if any.

- Grind edges
- Grind welded surfaces
- Remove welding spatter

- Clean and remove any surface dirt from the welded parts

In addition, the use of corrosion-resistance material such as stainless steel for distance pieces is another effective measure to be considered. Please note that welding procedure specification (WPS) approval is, however, required for stainless steel materials prior to any welding work.

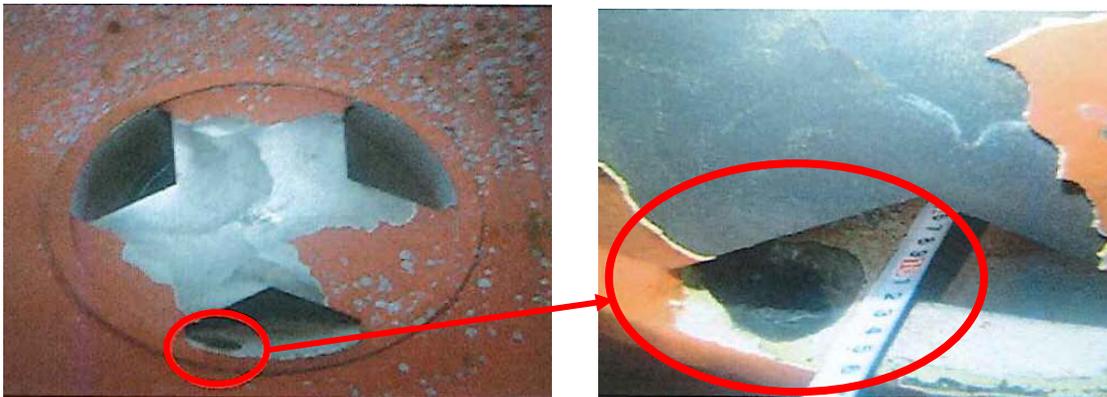
Picture 2 Corrosion on/around welded parts between distance pieces and bluff bodies

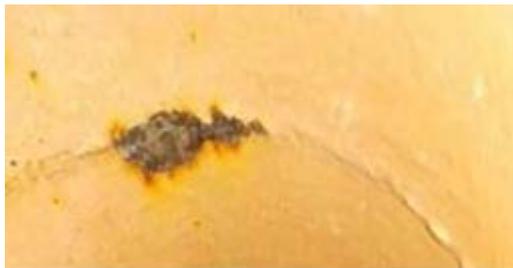
Picture 3 Paint peeled off at butt-welded parts of distance pieces
