Cracking at the Big Ends of Taper Sections of Water Lubricated Propeller Shafts

## Technical Information

No. TEC-1233  
Date 30 April 2021

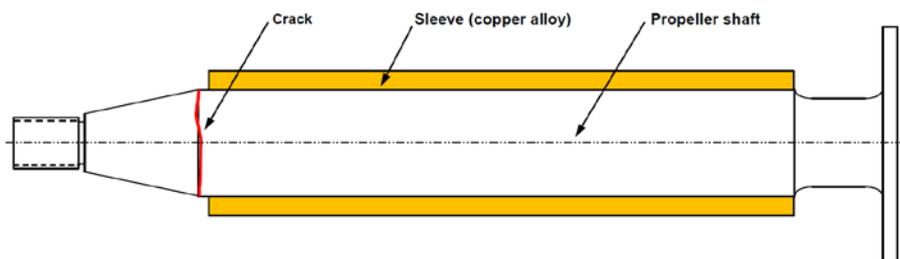
Although cracking at the big ends of the taper sections of water lubricated propeller shafts (as shown in Figure 1) is considered to be rare, it is something which is confirmed from time to time according to survey reports, etc. This kind of damage is usually discovered after a propeller shaft has been withdrawn during propeller shaft inspections and in some cases may require the immediate replacement of the shaft, which is something that will greatly impact the ship's operation. Figure 2 shows a recent example of such cracking that required the immediate replacement of the propeller shaft.

Figure 1 Location where cracking occurs

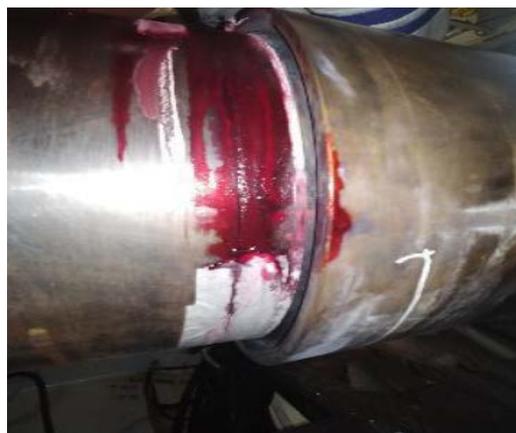
Figure 2 Recent example of cracking that required replacement of the propeller shaft

Multiple factors may contribute to the type of cracking shown in Figure 2, but sea water ingress into the propeller shaft is considered to be the dominant cause. When the surface of a steel propeller shaft that is unprotected by a copper alloy sleeve comes in contact with even a very small amount of sea water, the fatigue strength of the shaft will be dramatically reduced due to the corrosive effects of the sea water. The continued exposure to sea water and resulting loss of fatigue strength it causes will over time almost inevitably leads to crack initiations. Therefore, measures to prevent sea water from entering the propeller shaft and coming into contact with the exposed shaft surfaces are vital to avoid this kind of damage.

Based on the above-mentioned points, it is strongly recommended that all concerned parties make sure that the two protection layers are always properly installed and maintained, especially during reinstallation after propeller shaft withdrawal.

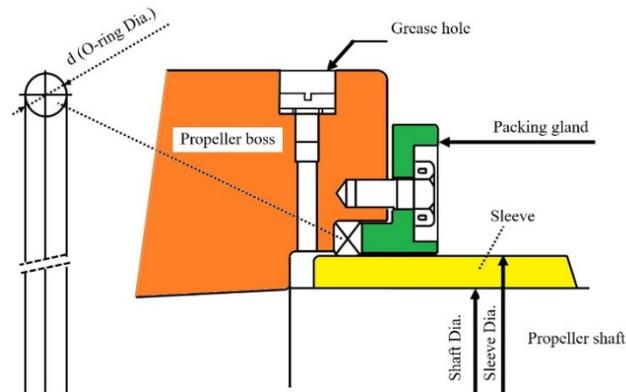
A two-layer protection strategy (as shown in Figure 3) is an example of such means that is usually employed. The first layer is a properly designed and installed O-ring, while the second layer is a layer of grease that fills up the space between the propeller boss and the propeller shaft. These two layers work together to provide reliable protection for propeller shafts against sea water ingress and thus reduce the possibility of corrosion related cracking occurring.

Figure 3 An O-ring and grease layer providing two-layer protection against sea water coming into contact with the unprotected propeller shaft surface.
