Inspection of Lifiable Car Decks of Pure Car Carriers

## ***Technical Information***

No. TEC-0484  
Date 11 October 2002

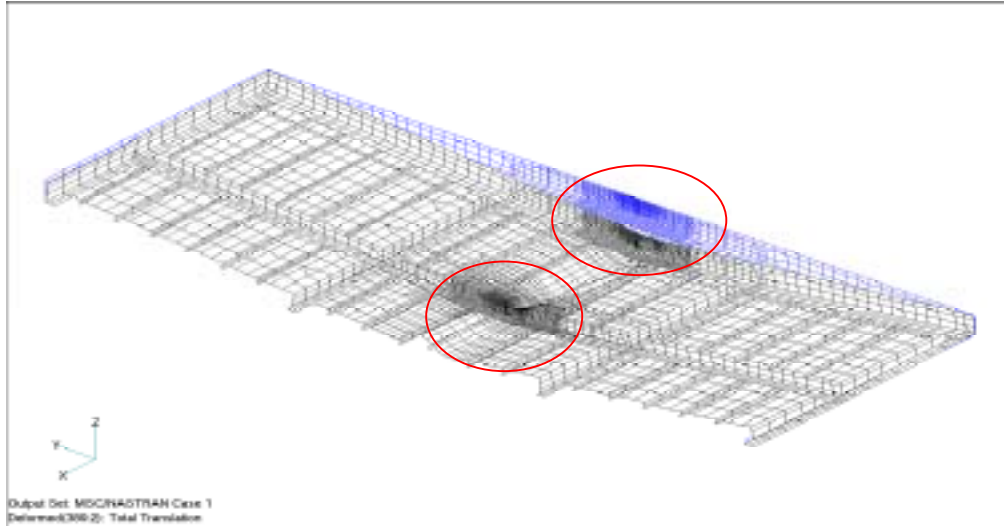
A simulation analysis was carried out examining the process until the deck deformed greatly, and it was found that large deformation occurred around the middle of deck transverse with long spans. (See Figure 1.) It is possible that the buckled deck and buckled transverse web resulted in a sudden reduction in the strength of main members. (See Figure 2.)

Figure 1. Bent Liftable Car Deck around the middle of Transverse (Sight from the reverse side of the deck)

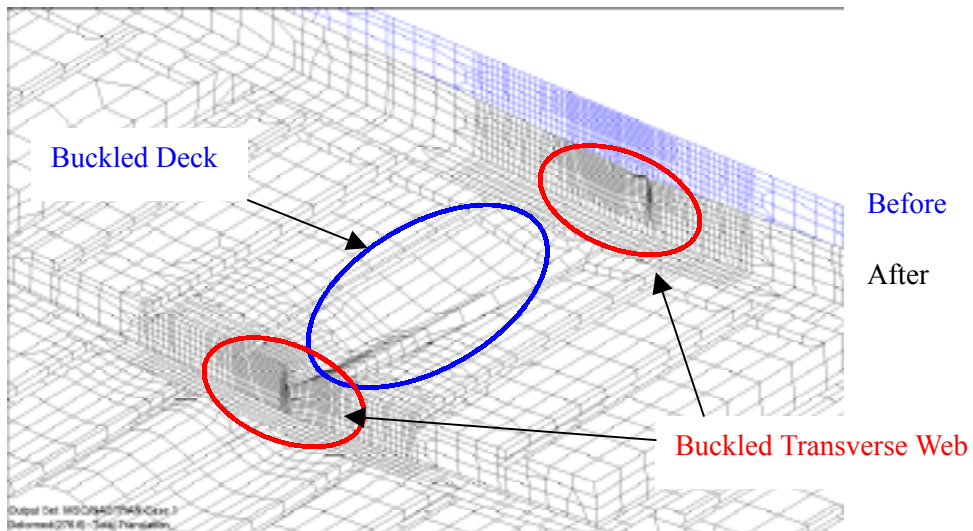
Figure 2. Buckled Liftable Car Deck Plate and Transverse Web (Sight from the reverse side of the deck)

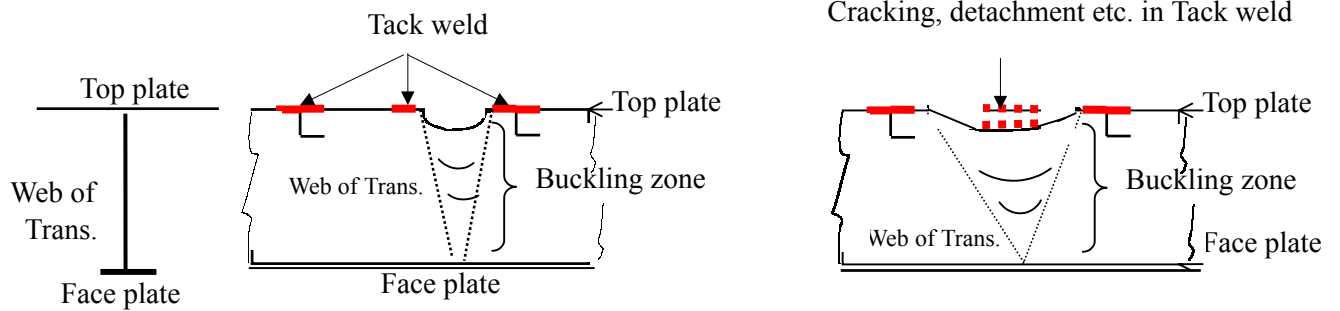
Also, it was found that the buckling strength for transverse web was reduced further if the tack welding between the web of transverse and deck plate was cracked or detached. (See Figure 3.) An instruction for surveyors has been prepared (see attachment) to help prevent the above mentioned type of accidents and in order to identify related damage prior to it becoming a major accident.

Figure 3. Cracking, detachment etc. in Tack weld and Buckled Trans.Web

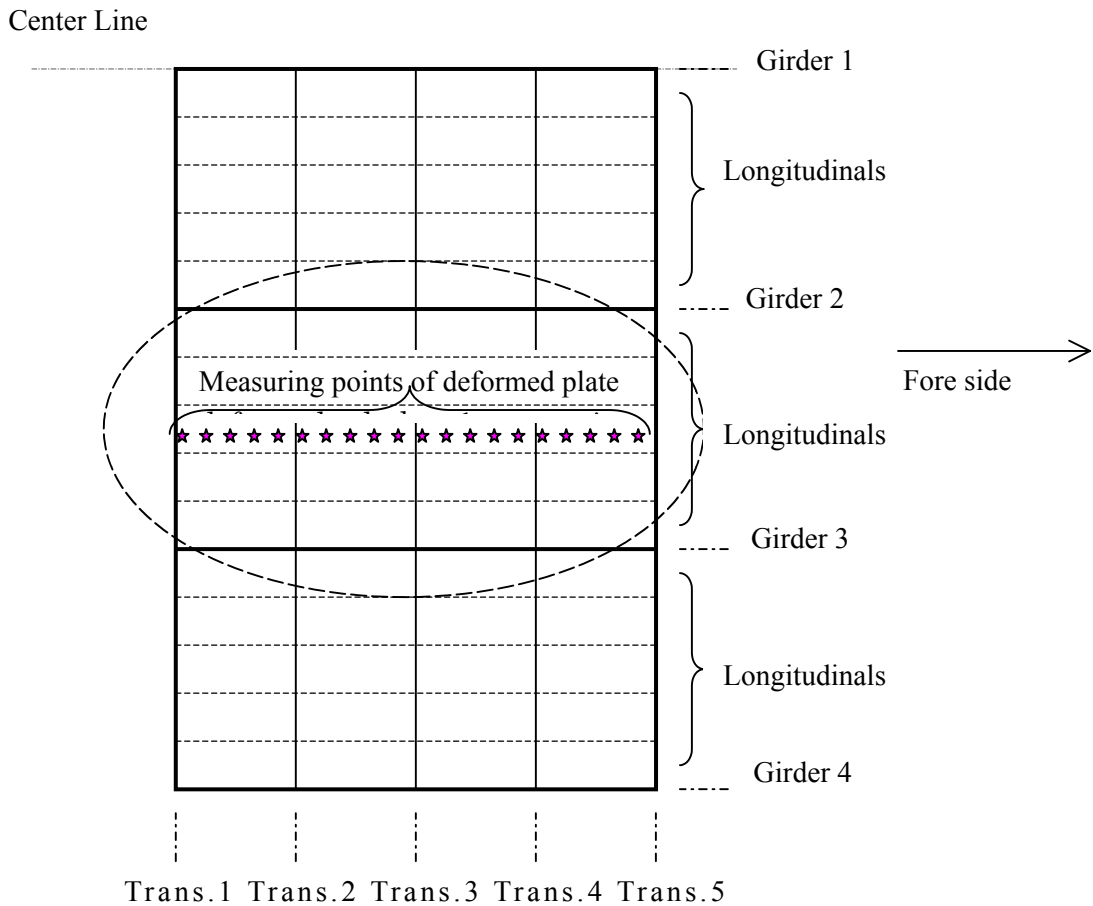
Figure 4. Measuring points of deformed liftable car deck plate (Longitudinal system) (Sample)

- (1) Local convex (∩) deformation of deck plates (See Photo 2.)
  - (2) Wide extent wavy deformation.  
In this case, measurement of the deformation should be carried out in order to grasp the exact condition ;  
Measurements should be carried out of a large deformation which is selected from the middle span of transverse members and the number to measure should be decided depending on the deformed condition. (See Figure 4.)

- Note significantly deformed plate around the middle of Trans. span
- Measure the deformation of the deck plate at 5 – 10 points depending on the deformation between Trans. and Trans.
- Measure the deformation by confirming horizontal level by the string method or a ruler etc. as a sample for a measuring method of the deformation.

If the deformation is the same as the approximate thickness of the deck plate at the position of the above transverse, or the deformation is the same as approximately twice the thickness of the deck plate at about the centre of a small panel (Panel surrounded by both transverse and longitudinal members), suitable reinforcement as a counter measure should be considered or a second close up survey should be carried out.

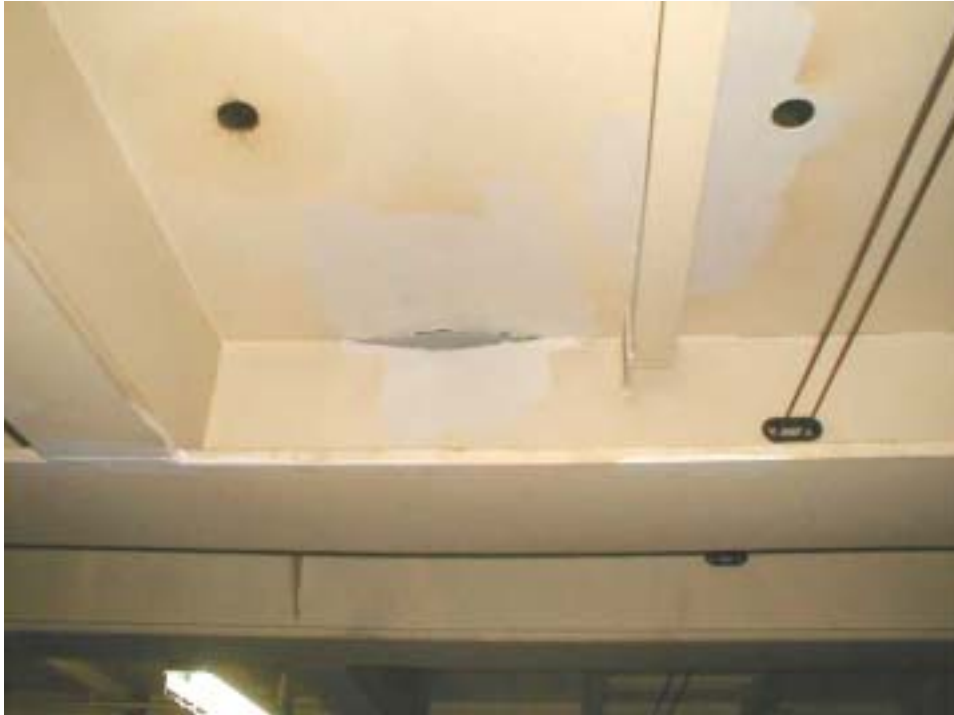
2. Welded parts between the deck plate and web of transverse.  
Be sure to examine whether there is anything wrong with the welded parts between the Deck plate and web of transverse  
Be sure to examine whether there is any corrosion, cracking, or breaking (See Photo 1.) etc. in tack welds in particular.

Photo 1. Detached tack welding between Web of Trans. and Deck plate

- In cases where there are notches or cracks in members for supporting the Lifiable Car Deck or the deck plate, stiffener, brackets etc. adjacent to the members, they should be removed and re-welded, additional brackets or carlings should be fitted for reinforcement if deemed necessary.
- In cases where welds between web of transverse and Deck Plate is cracked or detached, they should be removed and re-welded and also, the length of the weld should be longer than the original one. (Tack welding should be increased, one side of the weld should be continuously welded or both sides should be continuously welded.)
- In cases where the above mentioned welds are detached and the deck plate or the transverse web are deformed abnormally, carlings etc. should be fitted for reinforcement.

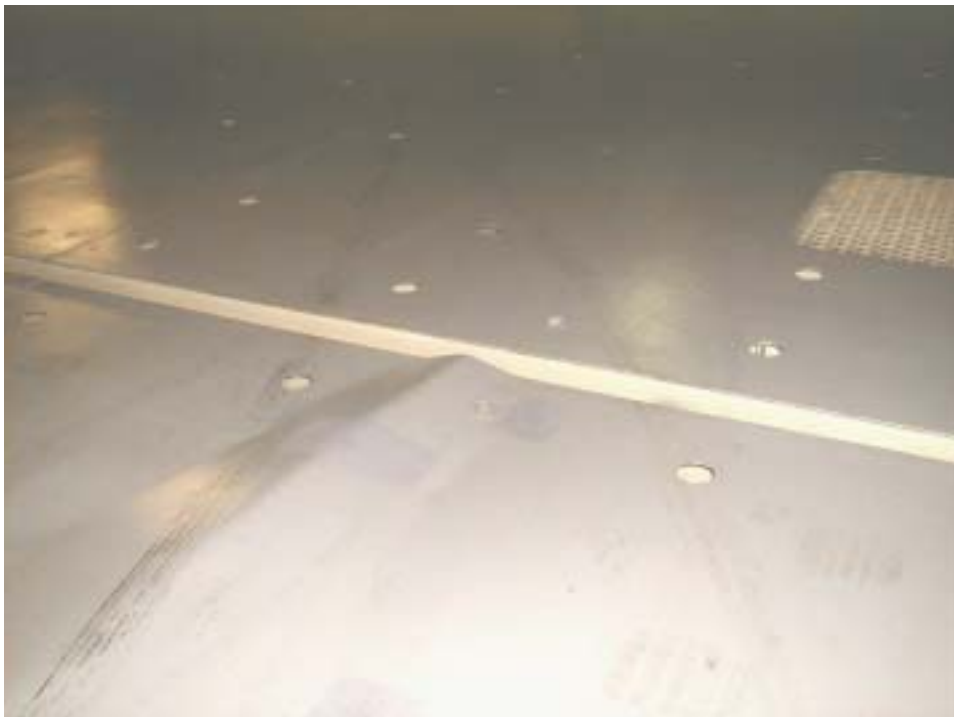
Photo 2. Abnormal deformation of Deck Plate (凸)
