英国政府、マーシャル諸島政府からのボートダビットのリミットスイッチに関する通知

テクニカル インフォメーション

No. TEC-0865
発行日 2011年9月28日

Subject: MALFUNCTION OF PROXIMITY SWITCH (MAIB SAFETY BULLETIN 2/2011)

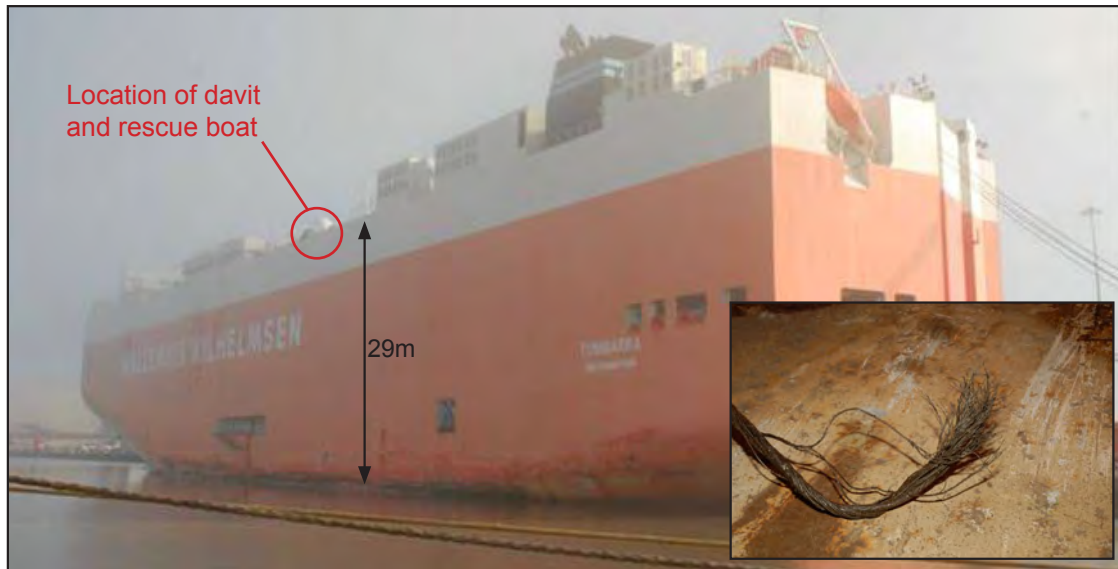
Figure 1

At approximately 1550 (UTC) on 7 February 2011, the fall wire of the rescue boat on board the UK registered car carrier *Tombarra* parted when the vessel was alongside in Royal Portbury Docks, Bristol, UK. The accident occurred as the rescue boat reached its stowed position on the davit following a monthly drill. Hoisting was not stopped before the davit reached its stowed position. The proximity switch, that should have cut electrical power to the winch motor before the davit reached its stops, failed to function. The rescue boat and its four crew fell nearly 29m (**Figure 1**) into the water below. One of the boat's crew died and two were hospitalised.

Vessel and parted fall wire

The fall wire was observed to be in good condition and when tested after the accident it achieved a breaking load of 137kN. The wire parted near the lower most davit sheave as the rescue boat reached its stowed position and the winch was still hoisting under power. Although the winch motor was rated with a nominal pull of 50kN, the maximum pull that it was capable of exerting when trying to overcome the increased resistance in the system during the final stages of hoisting would have rapidly exceeded the breaking load of the wire. The proximity switch, which should have prevented this situation from occurring, was tested in situ and was found to be defective.

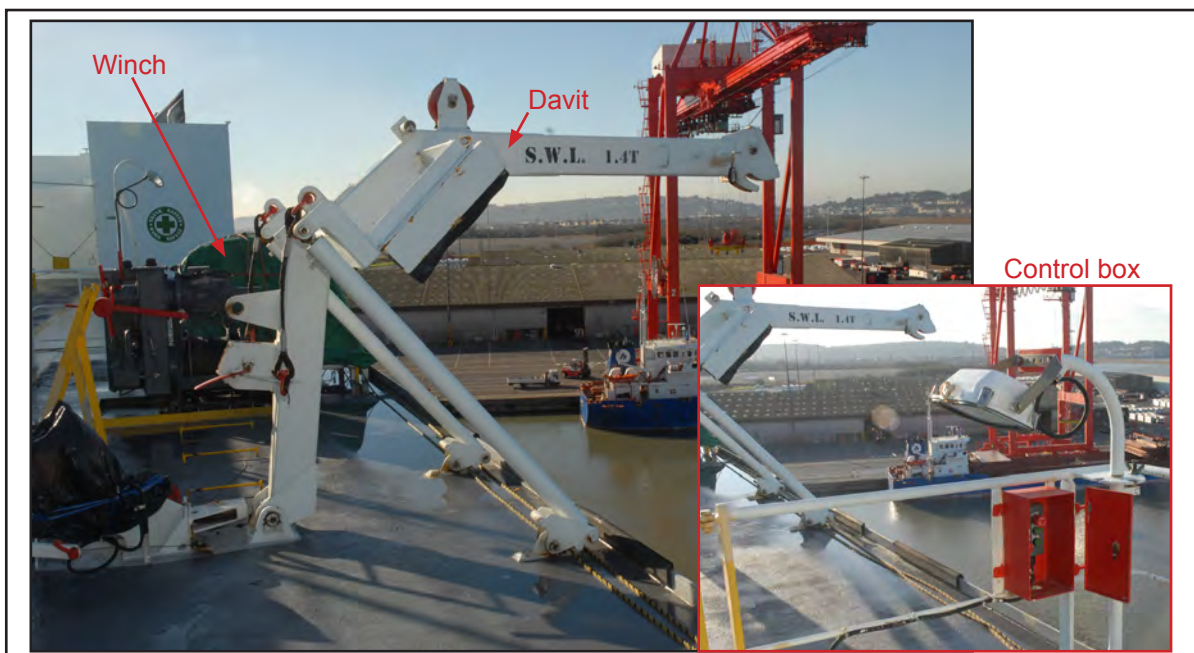
Figure 2

The 12mm diameter fall wire had a certified minimum breaking load of 141kN. Its safe working load (SWL) was 23.5kN based on a factor of safety of six. The wire was fitted to a single-arm davit (SA 1.5) (**Figure 2**), manufactured by Umoe Schat-Harding Equipment AS (Schat-Harding). The davit system was powered by a Schat-Harding W50 two-speed electric winch with a nominal pull of 50kN.

Davit system

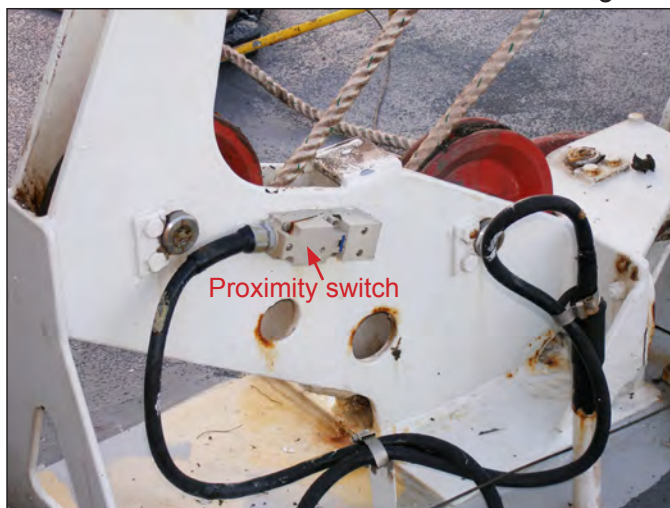
Figure 3

The winch was operated by a control panel sited forward of the davit. The boat was hoisted using the buttons on the control panel until the davit was near the stowed position. It was then intended that hoisting be completed manually by the use of a winch handle adjacent to the winch motor. To prevent the inadvertent operation of the winch when the rescue boat was in its stowed position, an inductive proximity sensor/switch (Telemechanique XS7-C40FP260) was fitted on the davit (**Figure 3**). The switch was intended to cut off power to the winch when the davit closed to within approximately 12mm of the sensor.

Proximity switch on davit

- The proximity switch fitted to the Schat-Harding SA 1.5 davit, and also known to be fitted to the SA 1.75 davit, is considered by its manufacturer to be inappropriate for use as a 'final stop' or safety device.

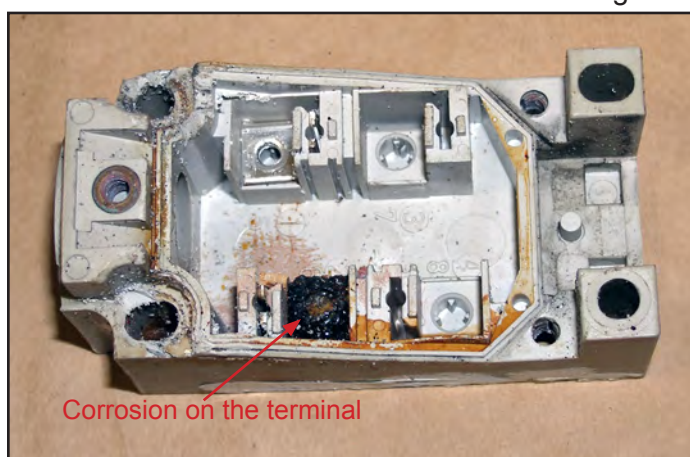
Figure 4

Water ingress into proximity switch

The switch was installed in 2006, and prior to the accident it was not tested before hoisting was commenced. Inspection identified that the switch body had been penetrated by water (**Figure 4**). However, detailed analysis highlighted that the switch malfunctioned due to an unrelated electronic fault. The MAIB is aware of both inductive proximity and mechanical limit switches fitted on other vessels that have also failed to operate correctly. However, none are known to have resulted in a similar accident.

- The fitting of the proximity switch was not compliant with its manufacturer's instructions. As a result, the gland and cable entry were higher than the switch body and its susceptibility to water ingress was increased.

Schat-Harding has issued a Product Awareness Notice (PAN) to its customers highlighting the need to test the proximity switches fitted on its SA 1.5 and SA 1.75 davits on each occasion before hoisting operations commence, and recommends that the proximity switch is replaced every 2 years; it also highlights the need for caution when using pressure washers on deck.

- In the case of vessels fitted with the Schat-Harding SA 1.5 and SA 1.75 davits, follow the advice contained in the PAN recently issued by the manufacturer or urgently contact Schat-Harding¹ if a PAN has not been received.
- Ensure that all devices (inductive or mechanical) fitted to boat davit systems to prevent overload are tested on each occasion before a boat is hoisted and that such devices are not relied upon during operation.
- Follow manufacturers' recommendations regarding the maintenance and periodic testing, examination and replacement of safety devices, seeking clarification from manufacturers where ambiguity exists.
- Verify the effectiveness of watertight seals on electrical equipment fitted to boat davit systems on weatherdecks.
