Regarding the release gear mechanism, type SRS-37 which is equipped on lifeboats manufactured by Shigi Shipbuilding Co., Ltd.

Technical Information

No. TEC-0694
Date 13 April 2007

Prevention of falling accident of lifeboat equipped with our SRS-37 type release device

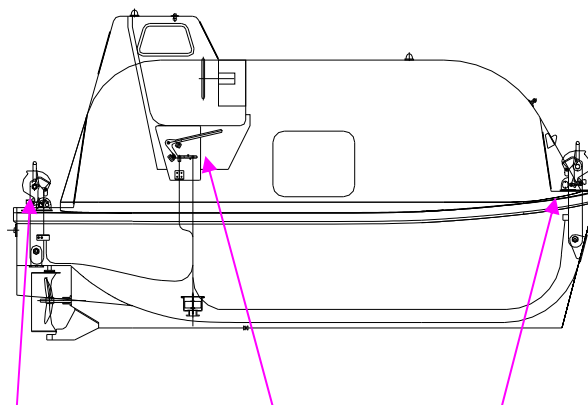
Please make sure to operate hook setting by three crews.

Helm position : one crew
Stem hook : one crew
Stern hook : one crew

Stern hook

Helm position

Stem hook

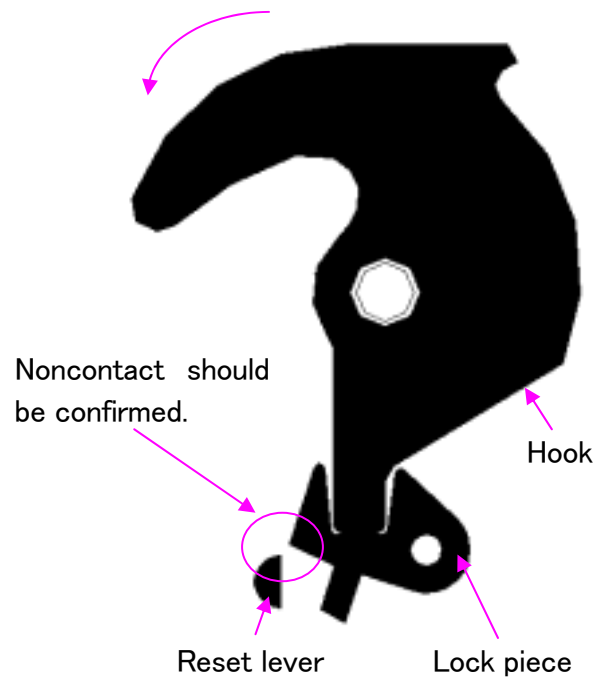
Crews at stem and stern should pull and hold hook until it is stable with both hands during hook operation, and noncontact between lock piece and reset lever should be confirmed.

Crew at helm position can set release handle smoothly (note 1) under this condition.

(Note 1) Normal operation force is approximately 5 kg.

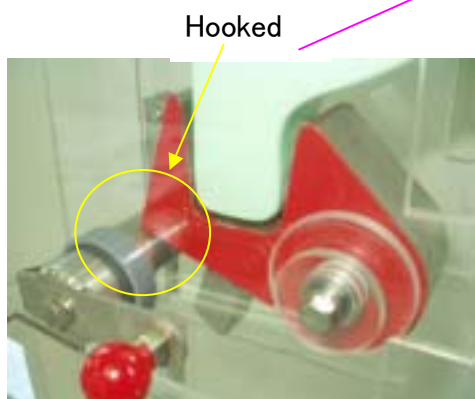
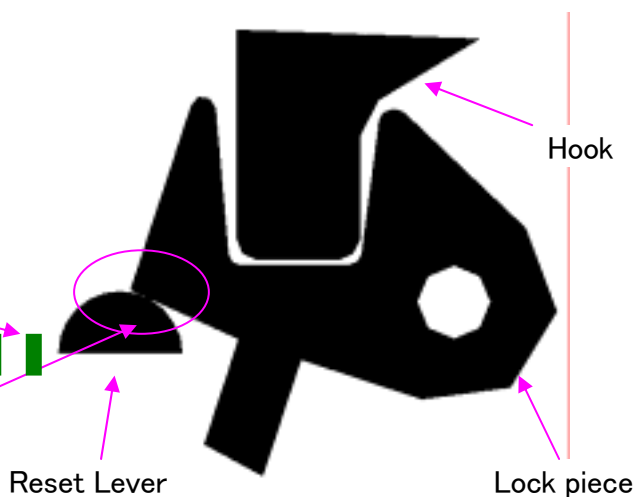
After finishing setting release handle, alignment of green mark on stem and stern hook should be confirmed.

In case that green mark on stem and stern hook are not aligned after finishing of safety pin insertion and release handle setting, some defect is considered in release device.

Pulling up and pulling down of lifeboat should never be done in this condition because falling accident occurs by hook opening affected sudden load addition.

In case that green mark on stem and stern hook are not aligned, damage of release cable and fixed angle or adjustment of release cable are required.

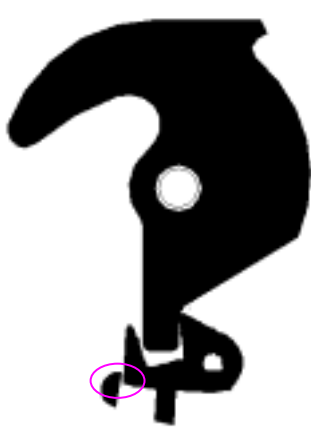
1. Insufficient pulling of hook by a crew at the time of hook setting after releasing, pulling up of lock piece becomes insufficient. (Picture 2.1 and Picture 2.2). In case that release handle is set under this condition, release handle cannot be set properly because lock piece and reset lever are interfered.

Picture 2.1
Insufficient holding

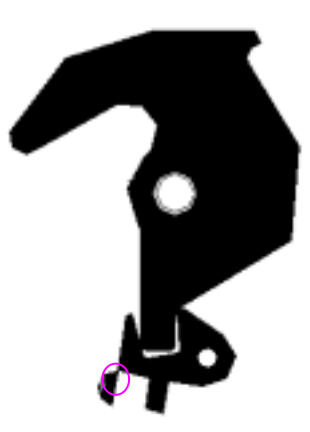
Picture 2.2
Insufficient holding
