Damage of SOx Scrubber Discharge Water Lines

Machinery Department, Plan Approval and Technical Solution Division, ClassNK

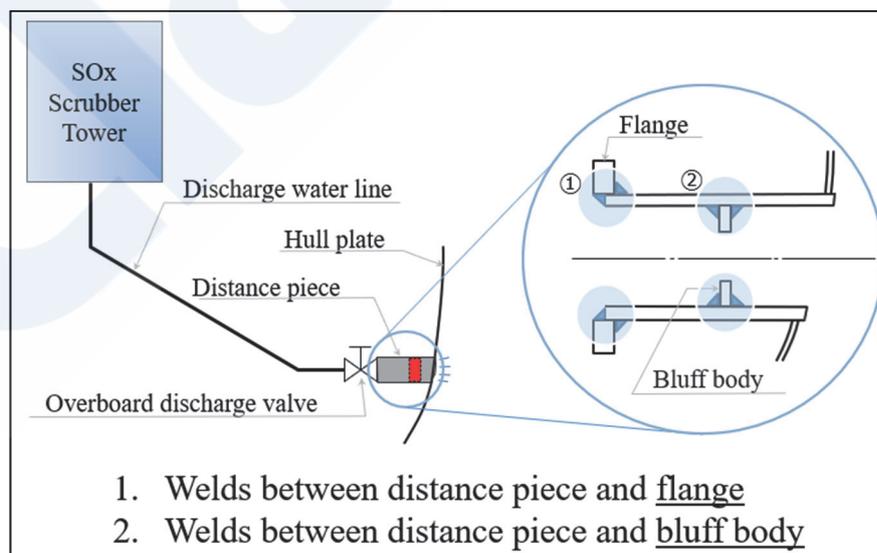
Fig. 1 Schematic of SOx scrubber discharge water system

According to the damage reports received to date, seawater leakage has been observed either on or adjacent to welded parts between distance pieces and their associated flanges (see Fig. 2), as well as between distance pieces and bluff bodies (see Figs. 3 and 4), as shown in Fig. 1. These reports indicate that the corrosion apparently initiates at welded parts and then continues to progress until it finally leads to seawater leakage into the engine room. Peeling of the painted surfaces of butt-welded parts of distance pieces (see Fig. 5) has also been observed.
