ClassNK PSC Bulletin

Date:	1 October, 2025
No:	NK-PSC-27
Attachment	No / Yes: — page(s)

Defective Isolation Valves of Fire Mains (SOLAS Chapter II-2 / Reg. 10.2.1.4.1 & Reg. 10.2.1.4.4)

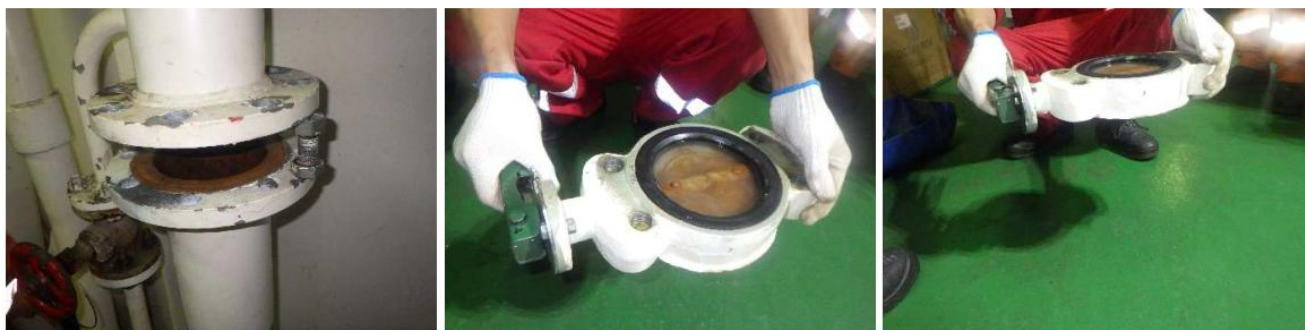
Photo Samples of Fire Main Isolation Valve Maintenance

As per the maintenance plan prescribed in SOLAS II-2 / Reg.14.2.2, the fire-fighting systems and appliances are to be tested by crew periodically. During the hose tests for fire mains, condition of each isolation valve is to be confirmed including both the valve itself and the forward piping section after the valve closed.

While the isolation valve is in the closed position and the fire hydrants are open, if the water leakage could not be stopped in the forward piping section, the valve is to be opened and repaired immediately.
